The Mumma Barn

# ANTIETAM

# Historic Structure Report

April 2000

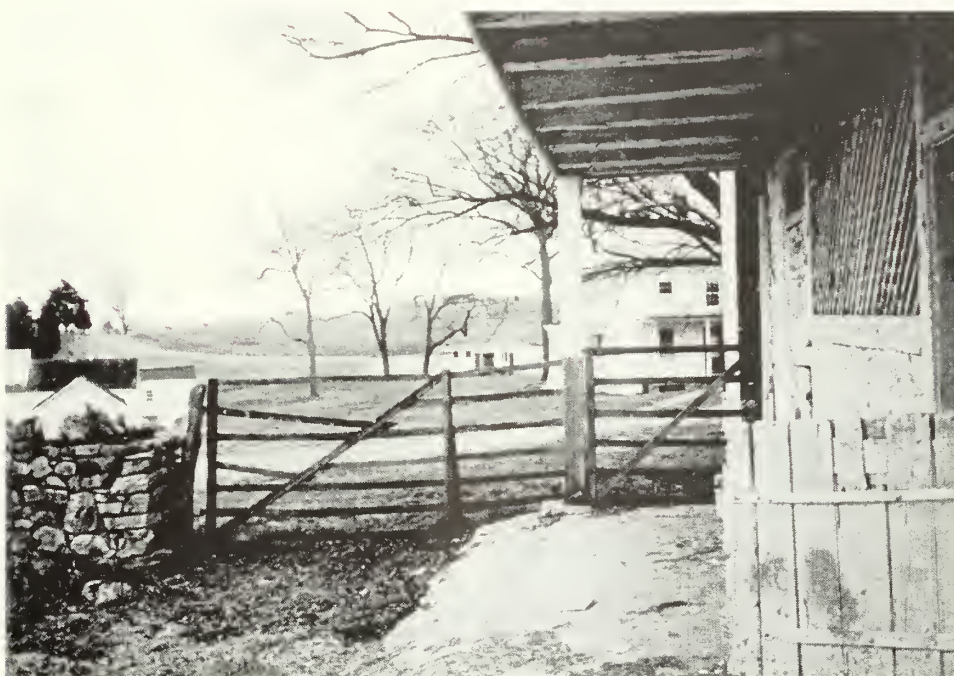
Another irregular feature of the Mumma Barn is the way the forebay is supported on either end. On the east corner, it is closed by an extension of the stone foundation wall (Fig. 38), and on the south corner, it is supported by a timber post (Fig. 39).<sup>45</sup> Although this variant does not appear in Fig. 32, Ensminger does discuss in his book the existence of a "Half-Open-Forebay Standard Barn", which would describe the Mumma Barn well.<sup>46</sup>

Figure 39: Posted-forebay end at southern corner of barn.

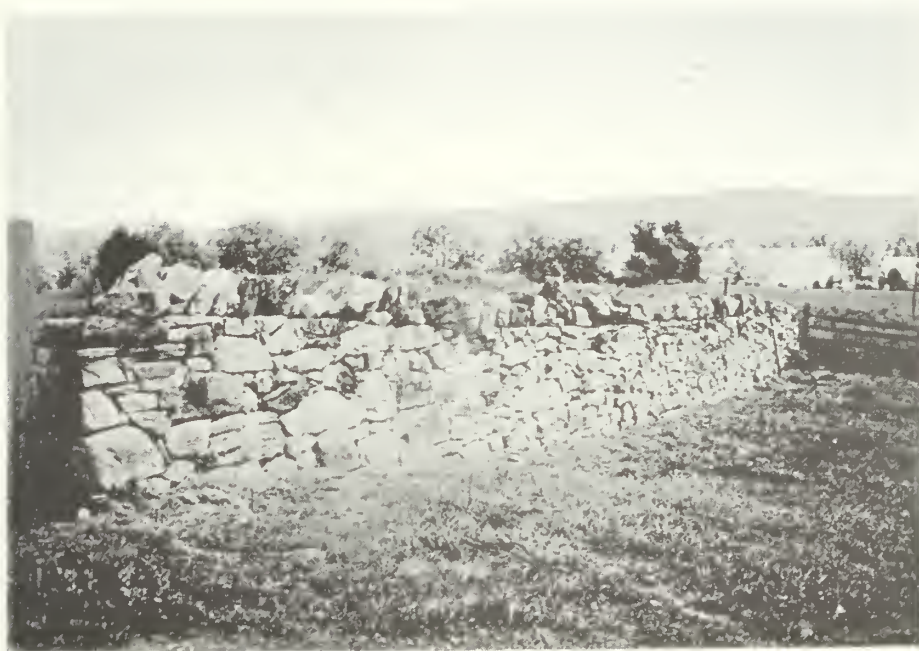
The original 60' x 60' barnyard is still delineated, although only a portion of its original stone wall exists on the south side (Fig. 69). Cultivated fields and pastures surround the barn. Cows graze nearby and corn grows high in the summer months. To the southwest of the barn lies the rest of the farm buildings. Directly adjacent is a combination tractor garage/chicken house built in 1936 (Figs. 70-71)<sup>61</sup> and a short distance away are the rebuilt farm house (Fig. 72), the original spring house with rebuilt roof (Fig. 73), and a series of small out buildings. A cemetery for the Mumma Family lies to the northwest (Fig. 74).

National Park Service, National Capital Region, List of Classified Structures (LCS).<sup>75</sup> It was repaired recently and is in good condition (Appendix K, Fig. 69, and Fig. 186). Defining the barnyard on the southeast side is barbed wire and scattered fieldstone, and on the northeast side there is a deteriorated wood fence. Broken nonhistoric wooden gates allow access to the yard from the southwest and northeast (Fig. 201).

Figure 69: Portion of stone wall along the southwest side of barnyard. This wall was recently repaired.

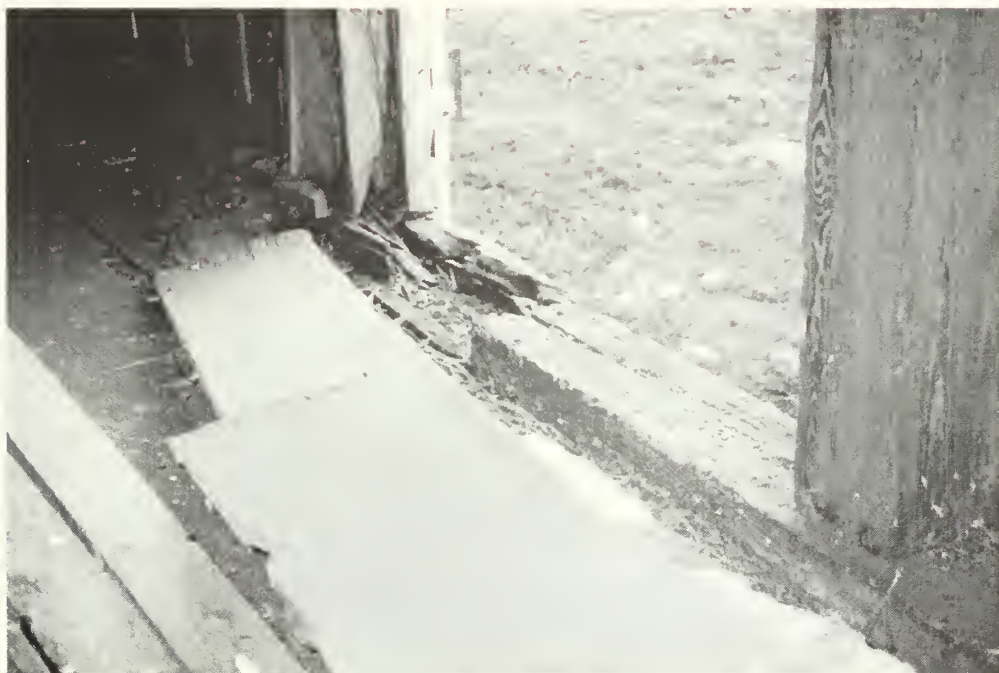
Figure 85: Rotted sill at threshold of winnowing door.

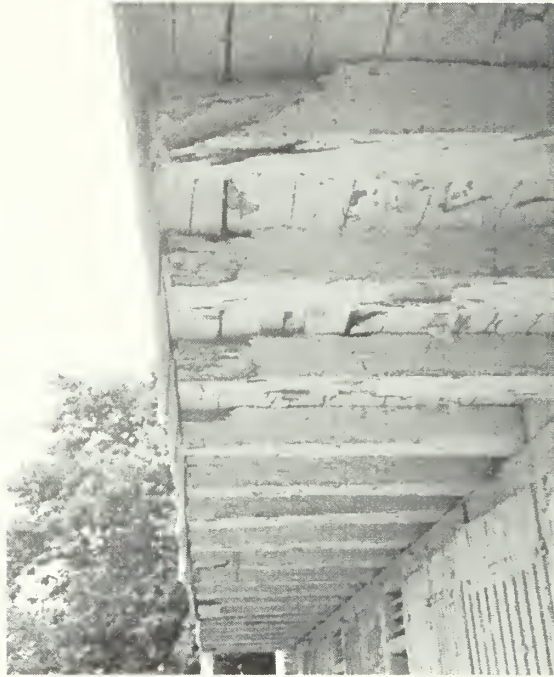
As mentioned above, several of the mortise and tenon connections on the bents are beginning to fail, especially on the southeast side of the barn. The southeast posts of the bents bear directly onto the ends of the floor joists. These joist ends are quite damaged and can no longer properly support the framing (see next section). At one of the central bents, failure has occurred where the rafters, wall plate, and tie beam intersect (Fig. 88). With proper repairs, these failures can be corrected to preserve the character-defining features and structural integrity of the barn.

Figure 89: Deteriorated joist ends over forebay in 1985.

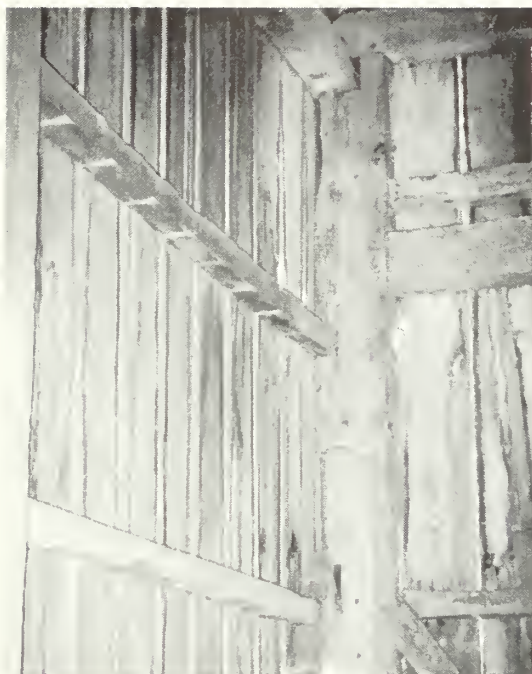
Figure 91: Detail of deteriorated joist ends.

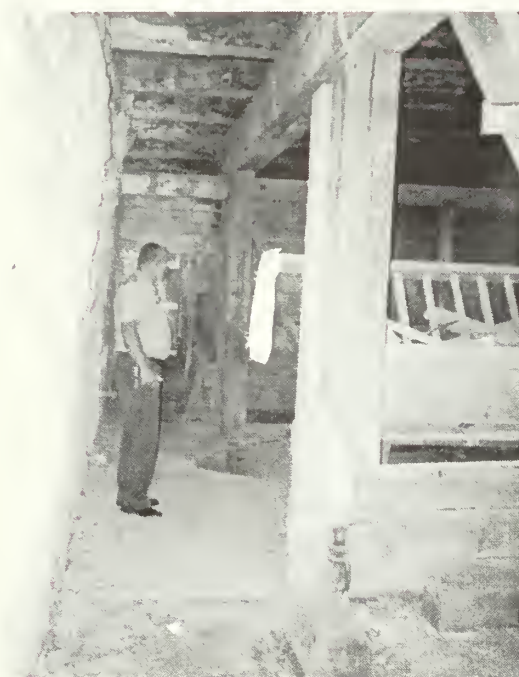
**Southwest Elevation at Upper Level:** The main vertical member in the southern corner of the barn has severe insect damage, probably from powder-post beetles and/or termites.<sup>63</sup> The damage is so extensive that it is now reinforced by an additional support (Fig. 92). There is also insect damage on some of the adjacent structural members, which is more pronounced on the vertical and diagonal members than on the horizontal members and the siding.

Figure 92: Main vertical member at the southern corner of the barn, which has been severely damaged by insects. Reinforcing was added at some point.

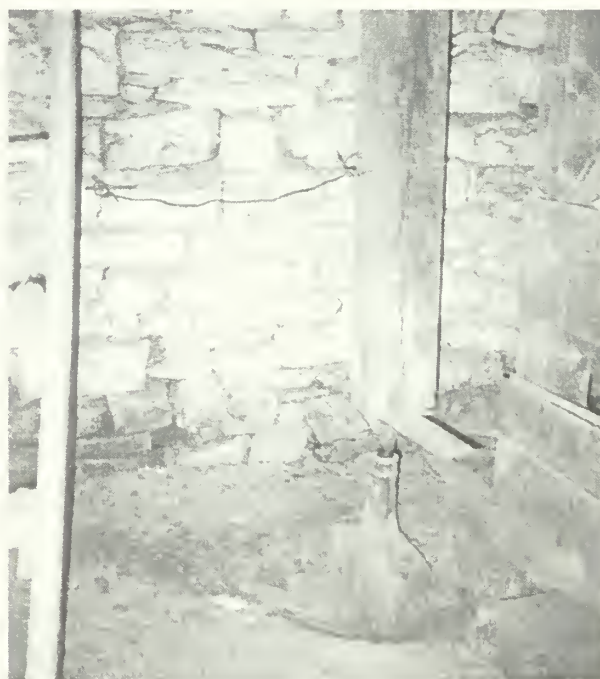
Figure 94: Bowing of the wall was evident as far back as 1985, as is apparent in this photograph.

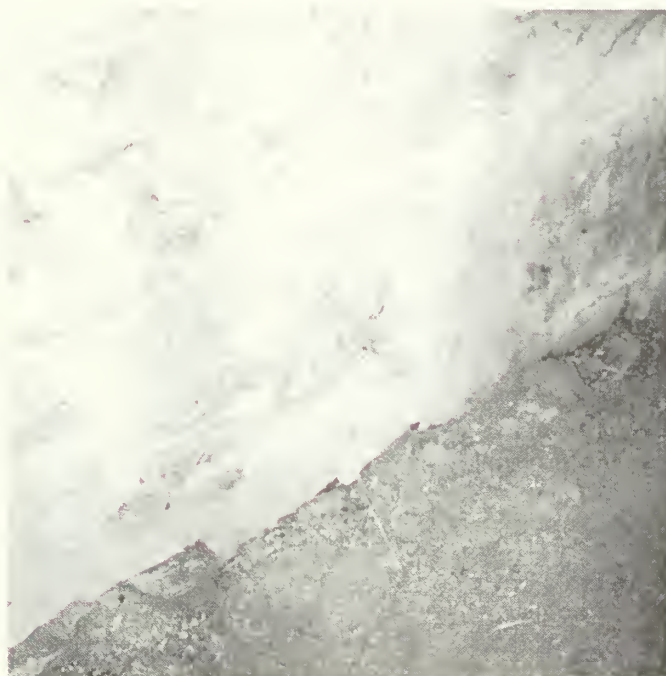
did indeed collapse on or about September 8, 1997 (Fig. 96) and was rebuilt in December of 1997 by park staff.

Figure 96: Collapsed northwest foundation wall. The wall came down in September of 1997 and was rebuilt in December of 1997.

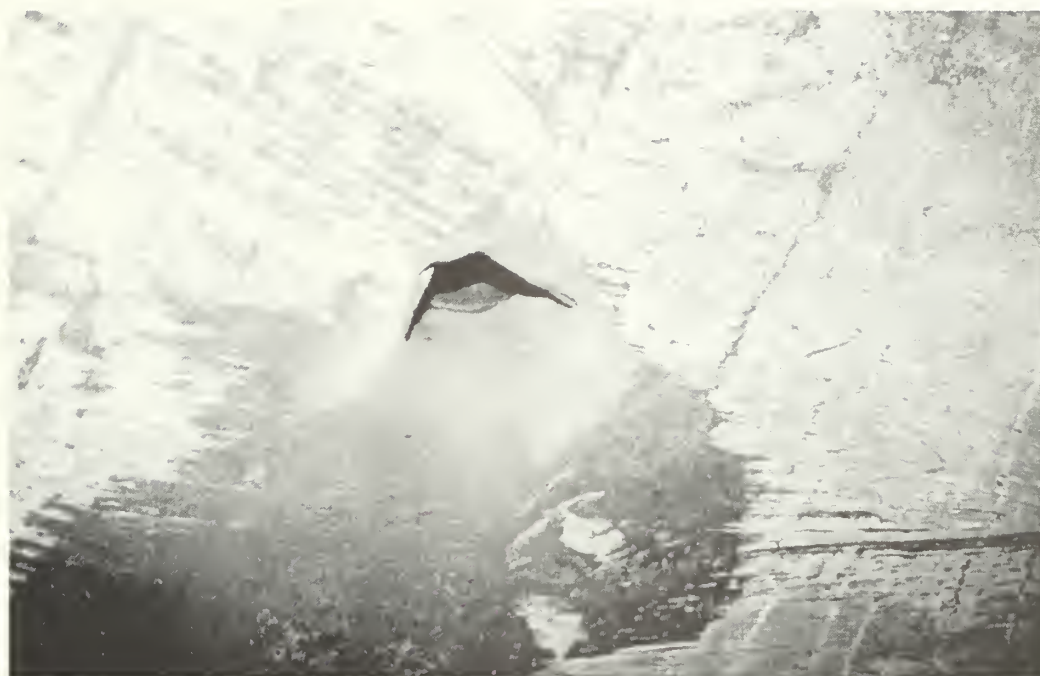
On October 1, 1997, an archeological excavation at the driveway confirmed that a cistern does indeed exist in this location. Everyone was quite surprised at the size and excellent condition of what was found. It is a large oval-shaped, brick structure, parged in plaster, which measures 8' x 17'-6" and is 6' high, spanning most of the width of the driveway into the barn (Fig. 98). The entrance hatch is framed in metal and a steel panel recessed into the frame closes the opening (Figs. 99-100). When the archaeologists came on site, this hatch was concealed by dirt, but it took little time to determine its location. Several openings at the top of the cistern allowed water to enter the enclosure. These are likely clogged, since the tank is mostly empty. There is still a small amount of water at the bottom after a heavy rain, but this water may be coming through leaks in the hatch (Figs. 101-104).

Figure 102: Interior of the cistern. Note piping for spigot...

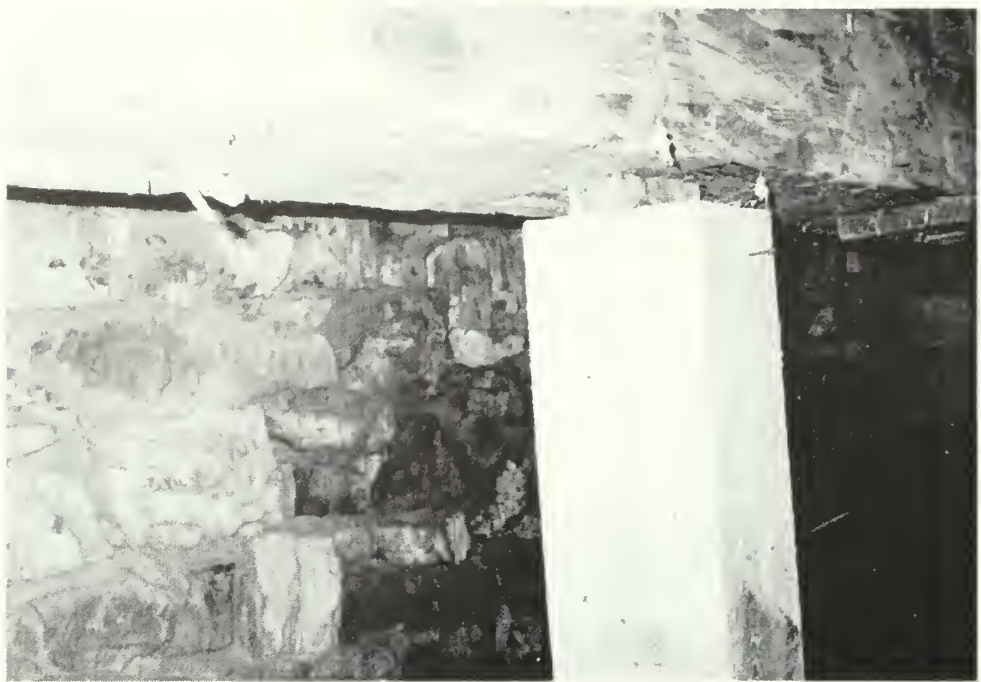
Figure 104: Two water sources on east end of cistern

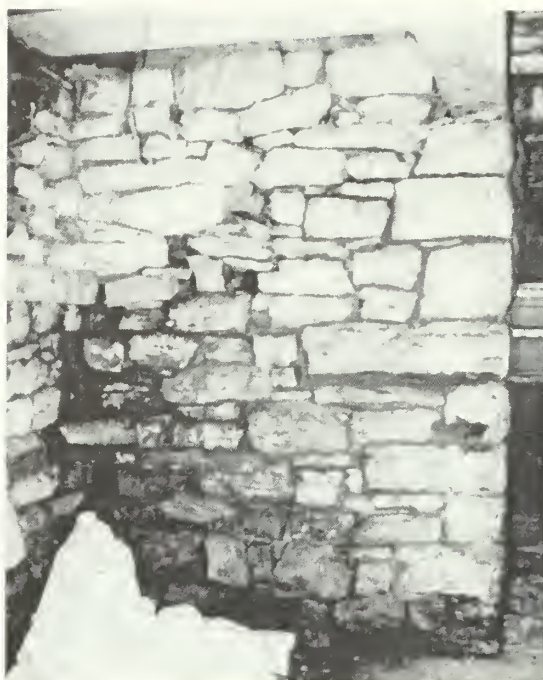
The stone typically used for these foundations is the rubble that dots the local fields. It has a high lime content (as does the mortar used to build with the stone) and when exposed to heat, it cracks and fractures and loses its structural integrity. A perfect example of this can be seen at the ruins of the Sherrick Barn. As the photographs indicate (Figs. 113-114), if the barn was to be rebuilt,<sup>65</sup> the damaged foundation, which was stabilized for safety and for interpretative purposes, would have to be replaced or significantly rehabilitated. Additionally, the stone, when exposed to extreme temperatures, often turns reddish in color (Fig. 115). The stone at the Mumma Barn shows none of this characteristic damage. There is an occasional stone that is pinkish in color as some of the original stones may have been reused, but it is generally in very good condition (Fig. 116). The same argument could be made when examining the basement of the Mumma Farmhouse. The stone there is also in good condition and was therefore, was replaced after the house was rebuilt.

Figure 116: Fieldstone foundation of the Mumma Barn. Note that the stone is generally sound and in far better condition than the Sherrick Barn foundation.

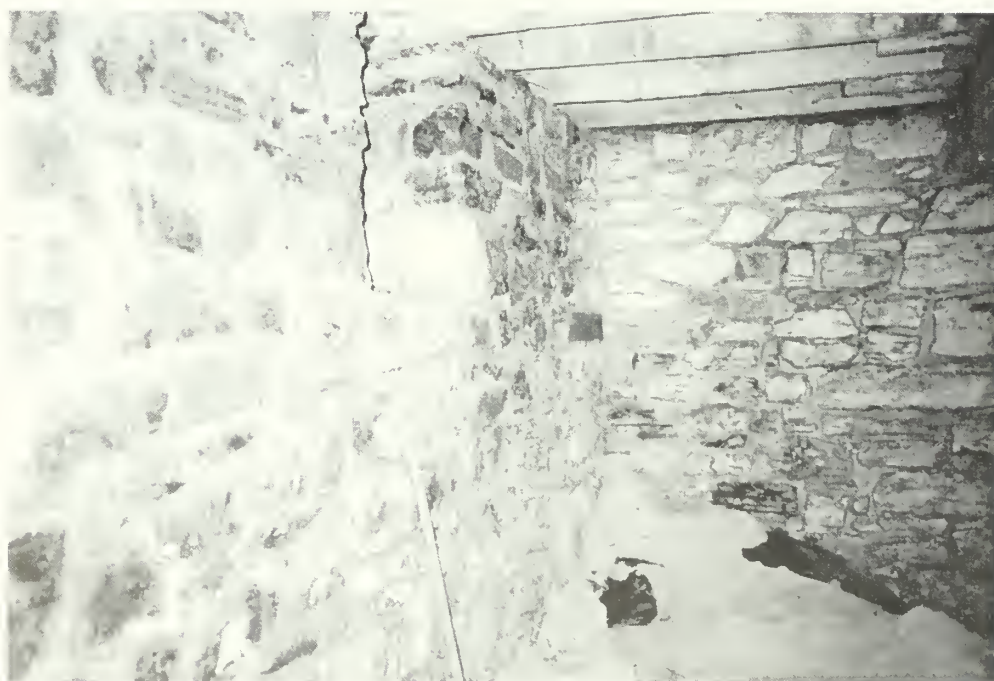
Figure 117: Western corner of foundation in 1992 prior to repointing.

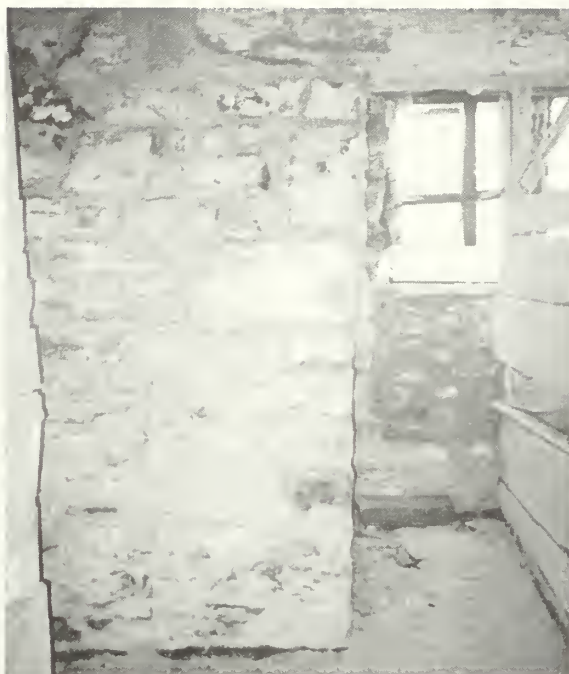
Figure 118: Western corner of foundation after repointing.

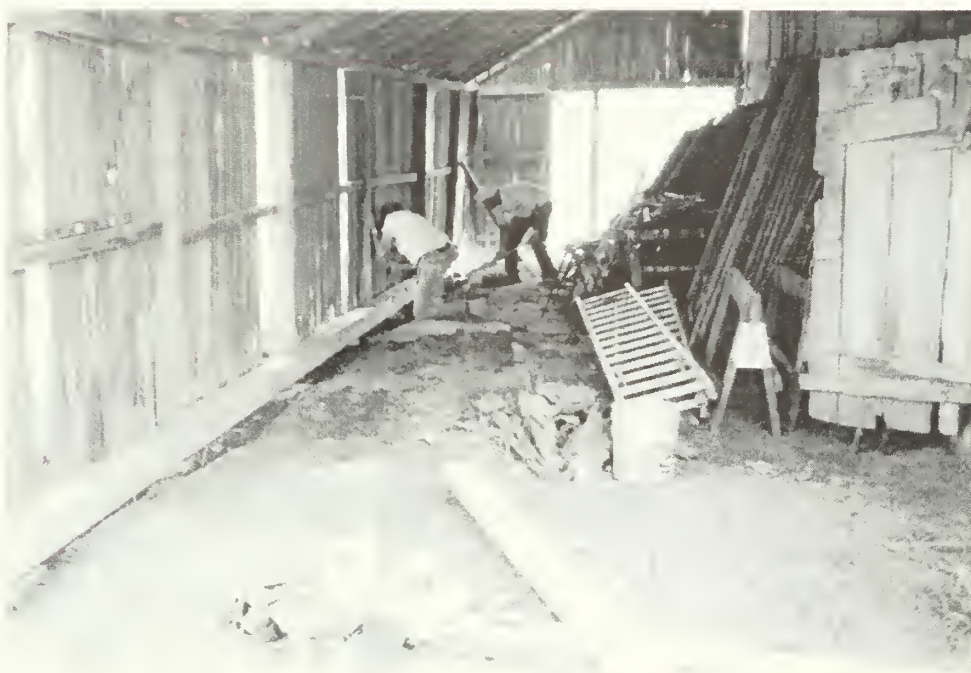
Figure 125: condition of implement shed in 1990, prior to stabilization (from the southeast).

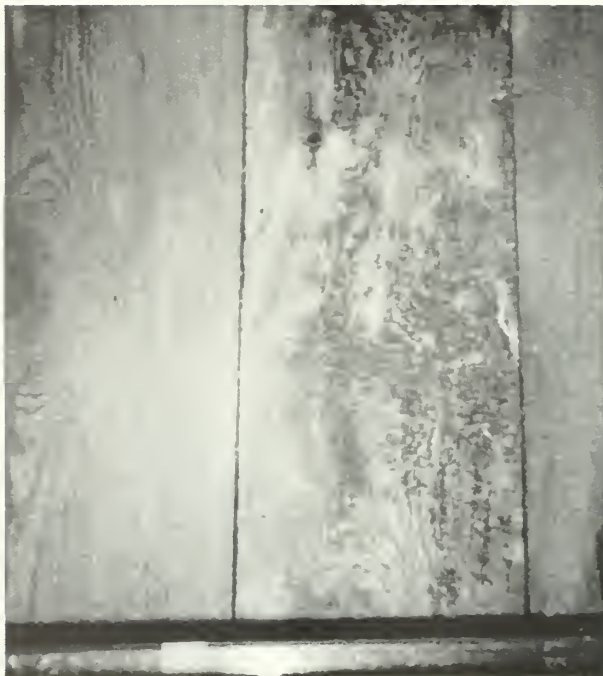
**North Outshed/Granary:** The condition of the north granary is fair. It is currently used to store National Park Service signs and miscellaneous lumber. The door leading into the granary is original, with a heavy piece of chain acting as a door pull and as a means of pad-locking the space. The granary is divided into three spaces by wood partitions. These were presumably used for storing grain. In two of the spaces, the walls are covered with galvanized sheet metal to act as a moisture barrier (Figs. 162-163). In the back space, there are old metal commercial signs for "Bonnie Bread" tacked randomly to the wall (Fig. 164). These signs look like they date from the 1940's or 1950's and were probably used for the same purpose as the sheet metal. For weatherproofing, the interior perimeter of the granary is clad with a layer of wood siding over the exterior siding. The floors are almost completely obscured by masonite, so their condition could not be assessed. The vertical wood siding on the interior of the granary and on the granary wall that faces the inside of the barn, are quite damaged by insects (Figs. 131-132).

Figure 131: Insect damage at interior siding of north granary.

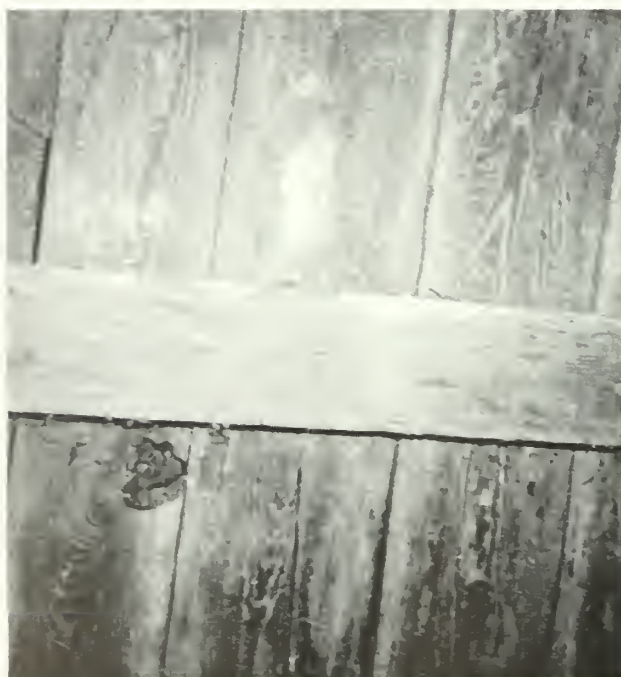
Figure 132: Insect damage at interior siding of west granary.

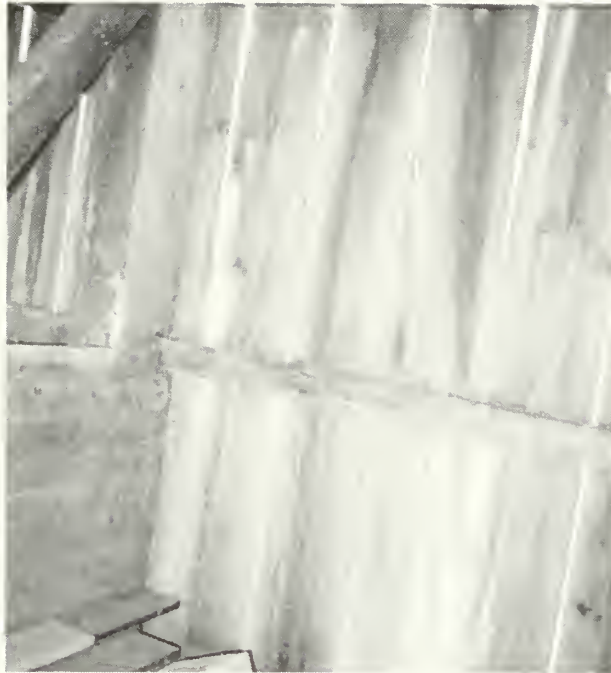
Figure 133: White bloom visible on interior siding.  
This is likely a fungal growth.

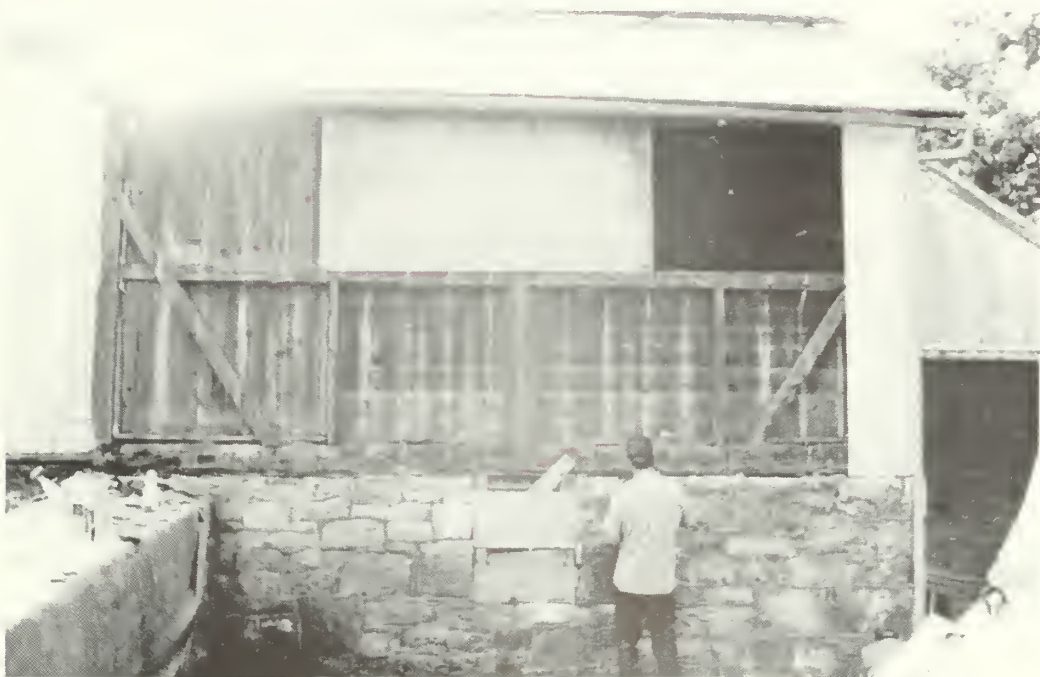
**West Outshed/Granary;** The west granary is now used for storage of the park's masonry supplies. It is divided into two spaces with wooden partitions. There is nonoriginal shelving in the larger of these areas (Figs. 165-166). According to park maintenance records, the siding and bottom sill of the west granary were replaced in 1992. It had become badly damaged due to poor drainage and insect infestation. It was also braced structurally at this time (Figs. 130; 134-136).

Figure 134: Repair and residing of west granary in 1993 by park.

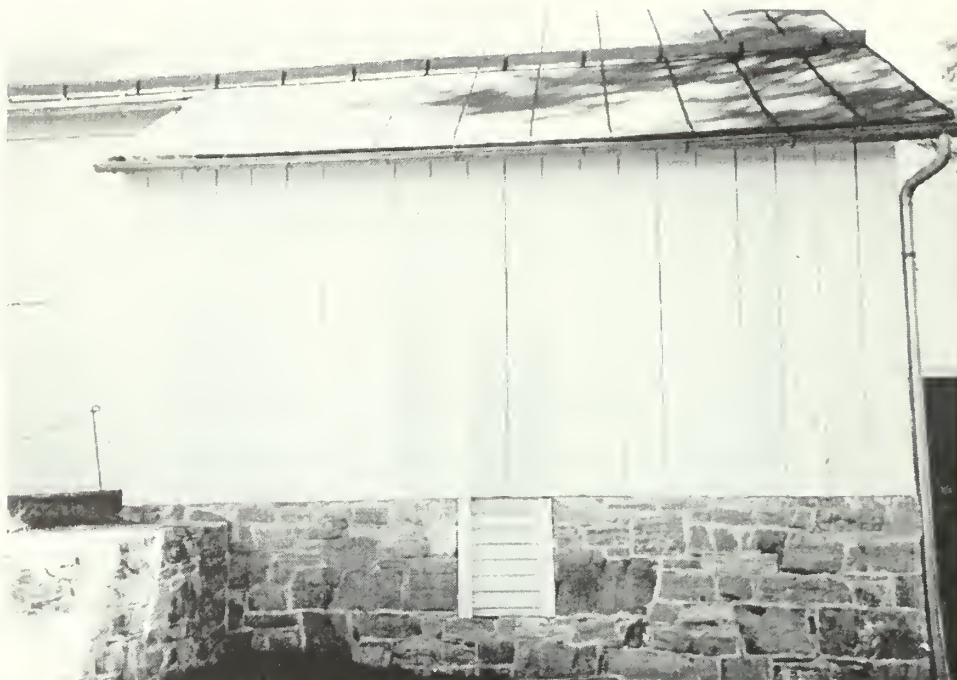
Figure 135: New siding at the west granary.

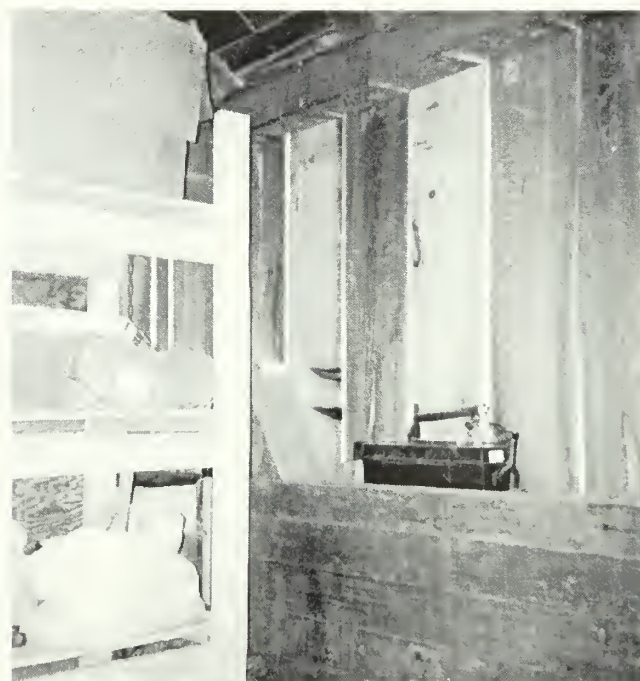
Figure 136: Interior of the west granary showing new siding in place.

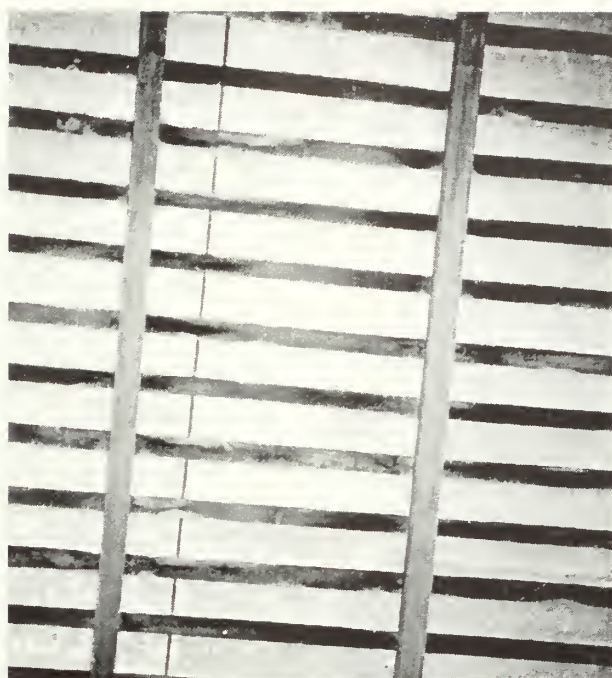
**Roof:** After examination of the underside of the existing roof, it appears that parts of the roof= structural system may have been replaced in 1936 when it was converted from wood shingle to sheet metal. It has not been determined whether the rafters are original or whether they were replaced as a result of this effort (Fig. 137).

Figure 137: Roofing lath at underside of ceiling.

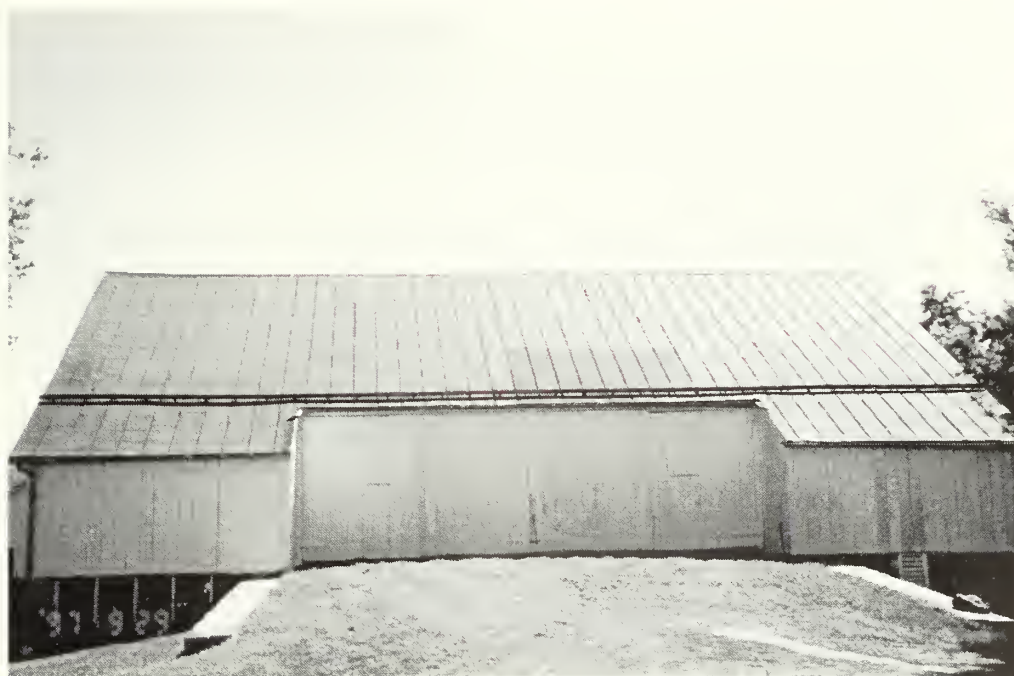
When viewing the exterior roof of the barn from the northwest (rear elevation), the color of the painted metal roof is dark brown (Fig. 138). When viewing the barn from the southeast (front elevation), the color of the painted metal roof is deep black. The roof was last painted in October of 1992, with a grey "Rustoleum" primer and a flat black Rustoleum finish coat. According to Richard Brown, the contractor may have tried to cut corners by thinning the paint. The color differentiation was not noticed until several months after the job was completed.

It can be assumed that the 1936 replacement siding matched the original siding in design and character, but that the current roof, which to the knowledge of park staff is still the 1936 version, is quite different than the original. The roof today must have a heavier, more substantial feel than the wood shingle roof of 1863. It has, however, protected the building well over the years, as it is still in good condition, considering its age, and the interior stays relatively weather-tight (Fig. 141). When the barn is rehabilitated, it will be replaced with a new standing-seam metal roof to match the one currently in place.

Figure 138: View of the barn's standing metal seam roof. To the knowledge of the park, the roof is still the 1936 version. No records indicate otherwise. Note the color of the roof is matte-brown.

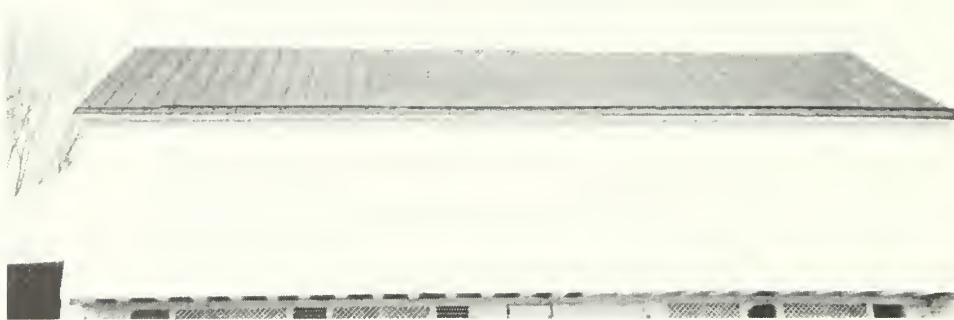
Figure 139: Peeling paint at southeast elevation of roof. Note the color of the roof is black.

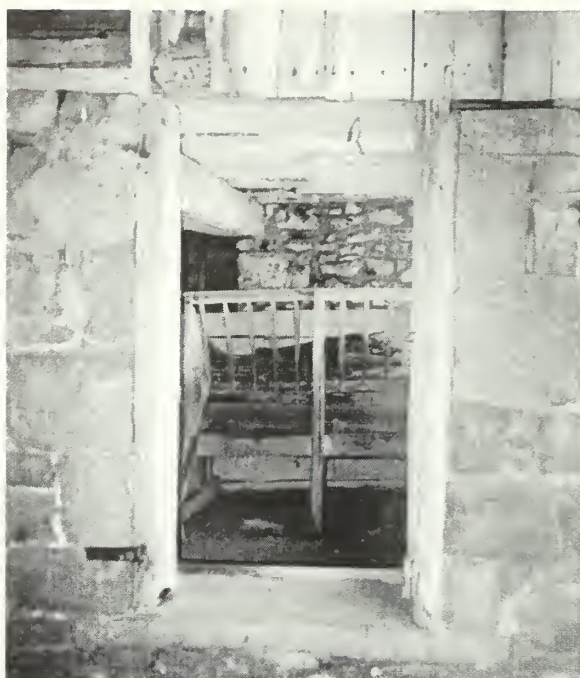
...two stables and one feeding entry have been concreted for dairy use, twenty-one head stalls for cattle were built in.<sup>70</sup> (Figs. 62-63 and Fig.145)

Figure 145: Entrance from north end of barn into dairy area.

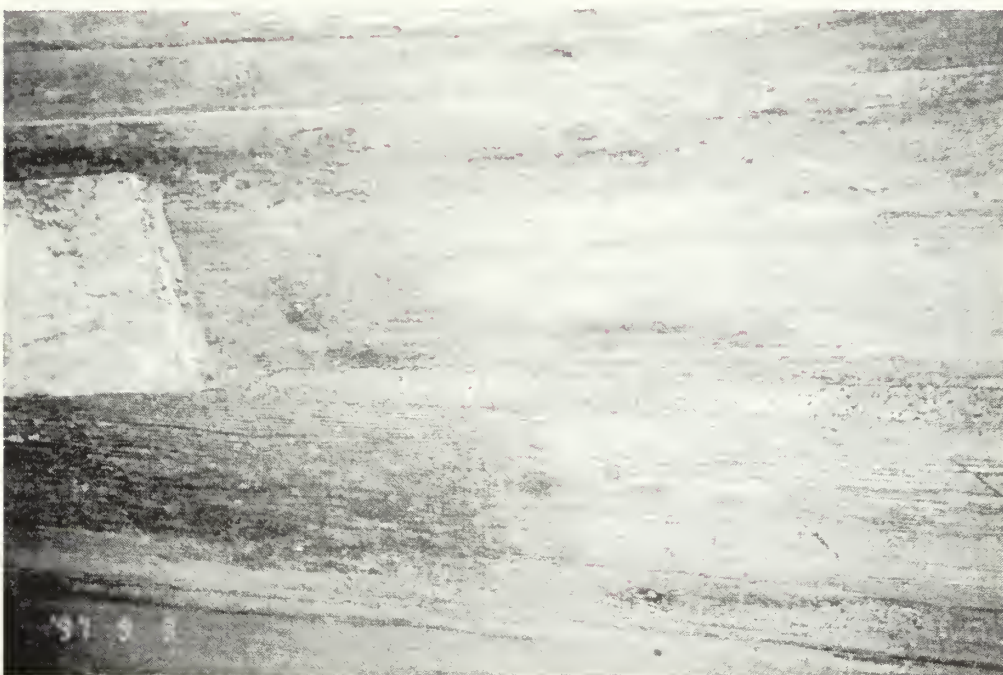
Figure 148: Original, wood threshing floor. Damaged area of the floor was patched with galvanized metal.

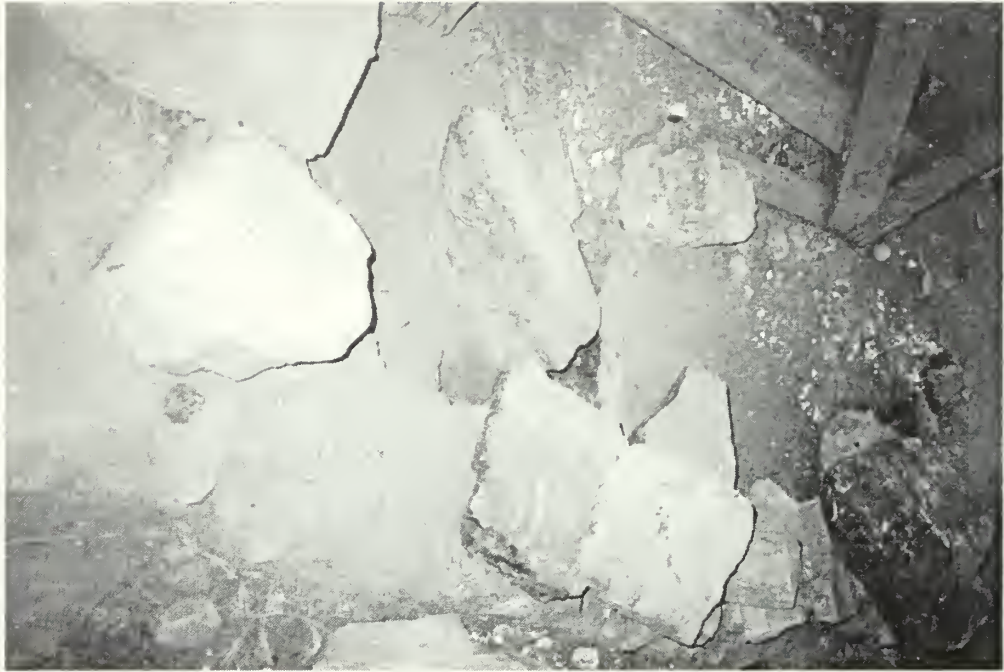
**Lower Level:** The general condition of the floors on the lower level is very poor, so poor in fact that it requires immediate attention. The topping slab of concrete at the dairy area floor (northeast side) is in total disrepair, primarily due to the infiltration of rodents, specifically ground hogs (Figs. 153-154). The floor in the remainder of this level is dirt (compacted clay and mixed aggregate), also seriously damaged by rodent tunneling (Figs. 155-156). The only other floor material is in a feeding area at the southwest side, which has rotting wood across approximately half its floor area (Fig. 157). When future work is done on the barn, the issue of how to keep the large population of destructive ground hogs from returning to the barn and causing more damage must be addressed.

Figure 153: Concrete topping slab in dairy area in a state of disrepair due to rodent infestation.

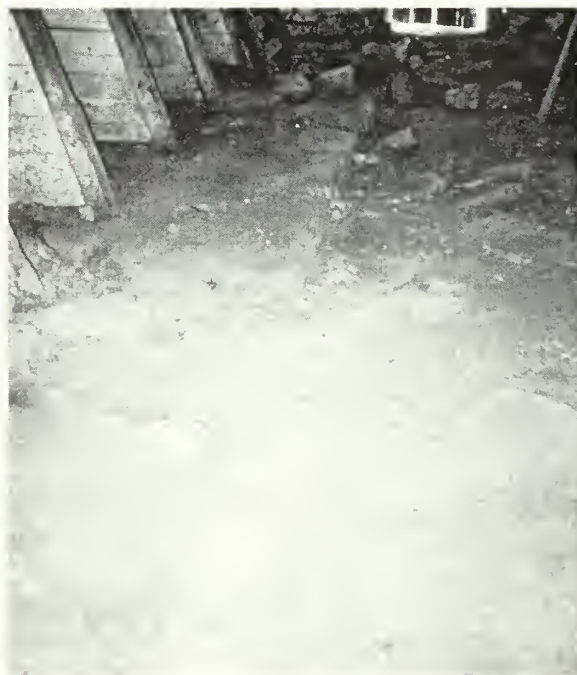
Figure 154: Deteriorated concrete topping slab in dairy area.

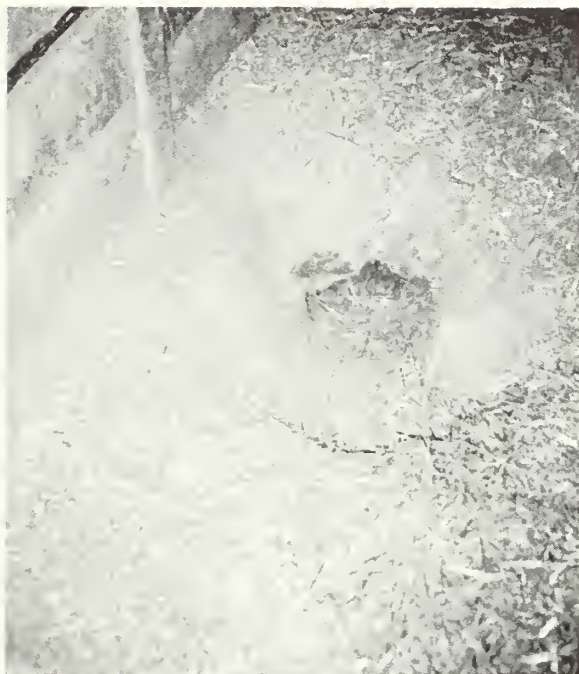
Figure 155: Damage caused by burrowing ground hogs.

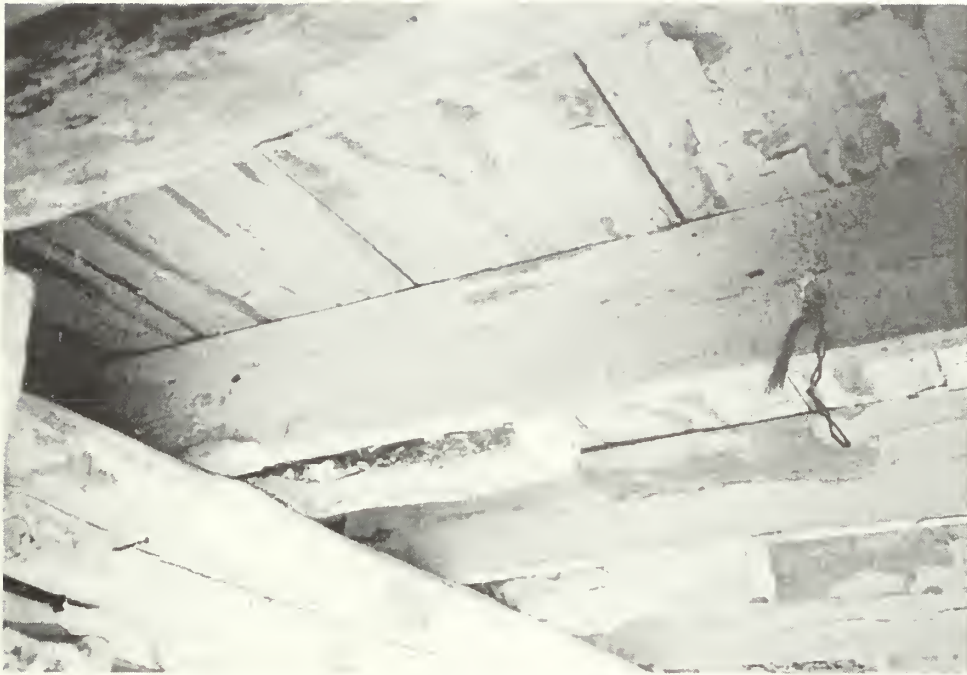
A curious condition that is visible under each granary is that the original log joists below, which support the floors of the granaries above, have been cut short and replaced by milled lumber (Fig. 159). It is not clear when or why this repair was completed, but one can speculate that the joist ends became moisture damaged and required replacement. Both the north and west corners of the barn traditionally have had drainage problems. The floors of both granaries may also have been replaced at this time. The floorboards are similar in appearance to the replacement floorboards just in front of the wagon doors (at the northwest elevation)(Figs.160-161).

Figure 159: Original log joist cut below outshed/granary. Typical under both outsheds.

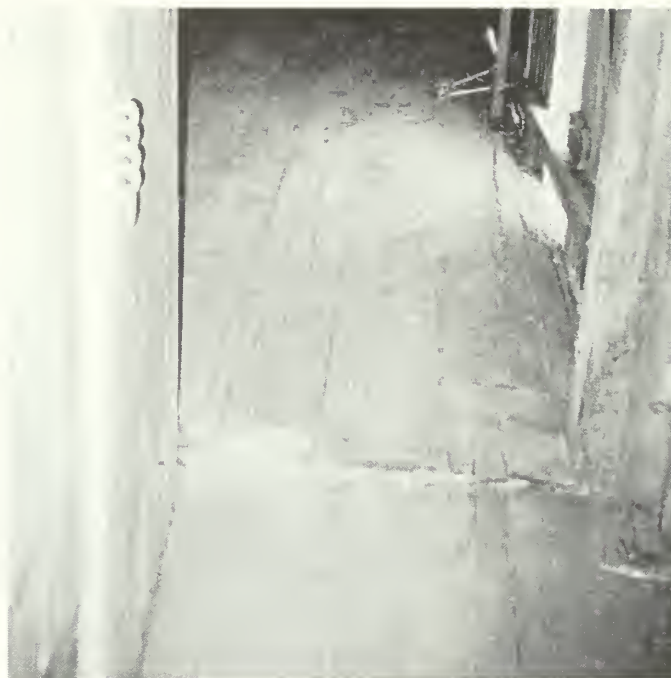
Figure 161: Floor replaced at granaries.

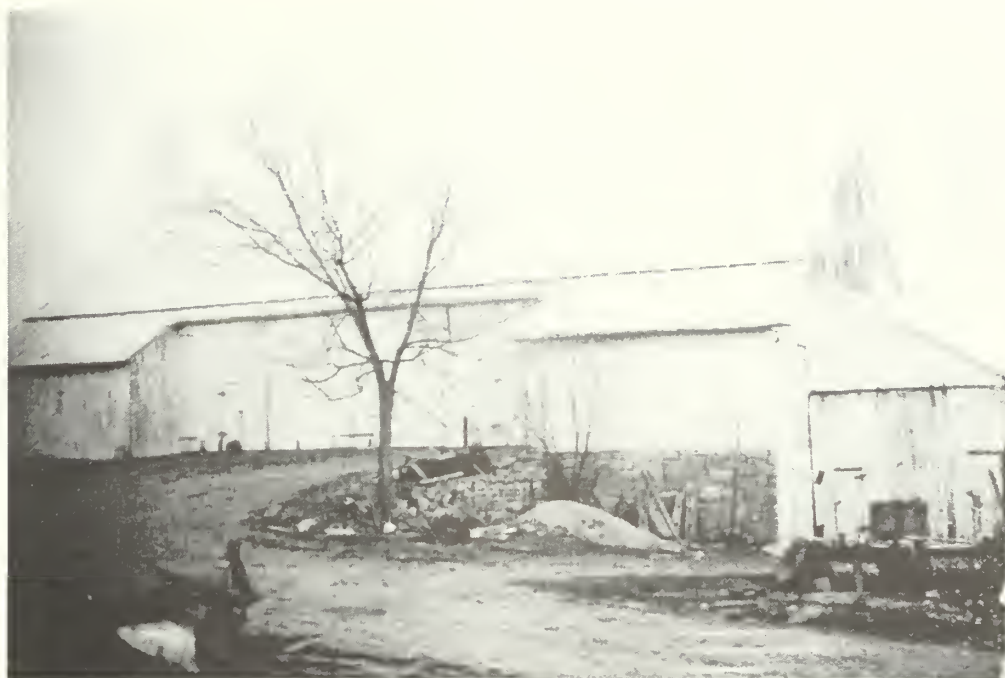
A continuous corrugated-metal shed roof covers both features (Figs. 170). This roof was repaired in 1991/1992 by the Williamsport Preservation Training Center as part of an emergency stabilization effort.<sup>73</sup> Also in 1992, deteriorated sliding wooden doors were removed by park staff from the northwest elevation of the wagon shed (Fig. 167) and not replaced, leaving it open on both ends. The siding and foundation of the wagon shed are in good to fair condition (Figs. 171-172).

Figure167: 1975 photograph of the wagon shed with the sliding doors still in place. They were removed in 1992 due to severe damage.

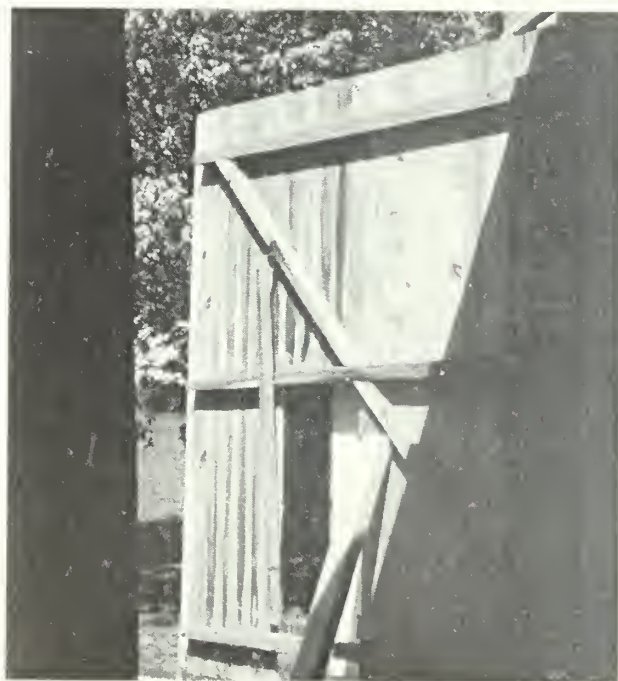
Figure 182: Northern-most wagon door (repaired in 1993).

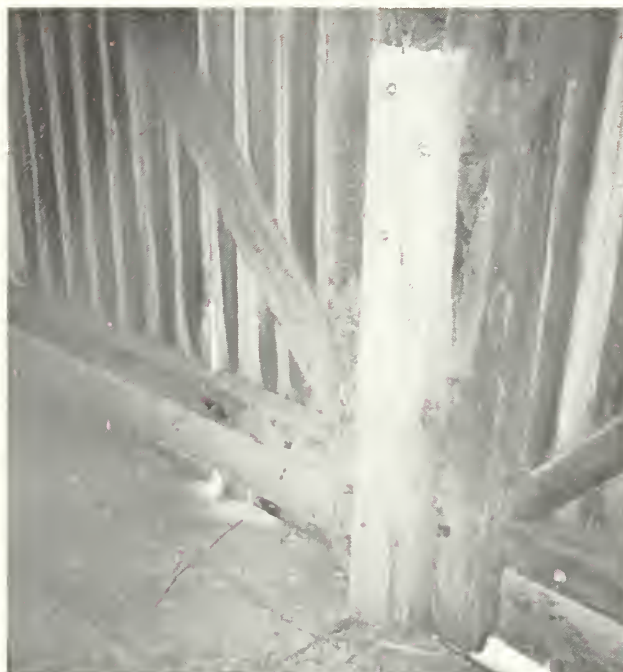
Figure 183: Post repaired by park in 1993 (due to Powder Post Beetle attack).

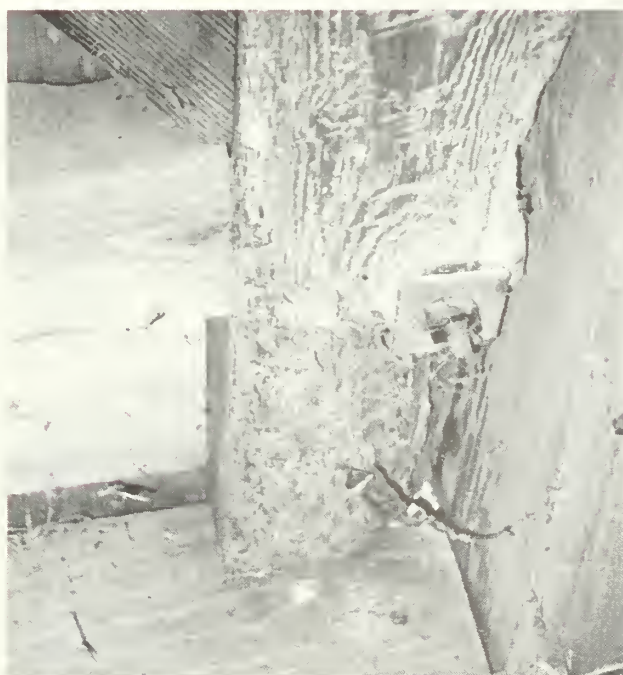
Figure 184: Post at the wagon doors currently in need of repair.

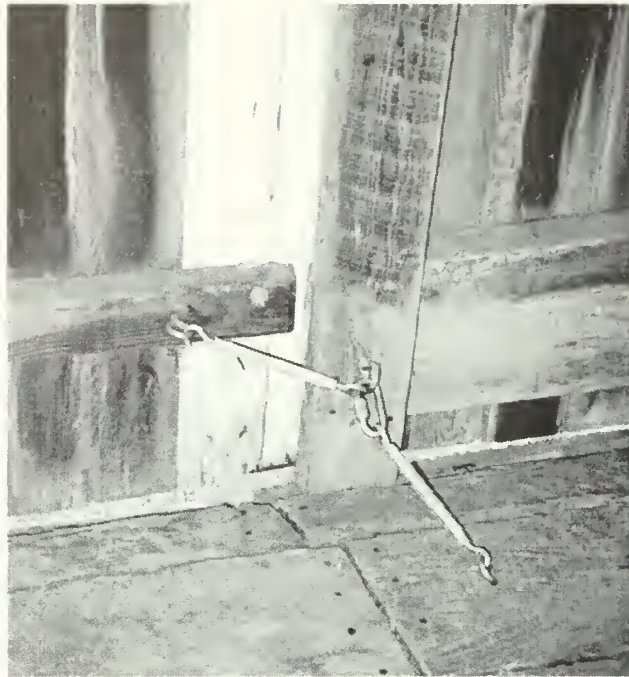
Figure 185: Modern hardware added by park maintenance to secure main wagon doors.

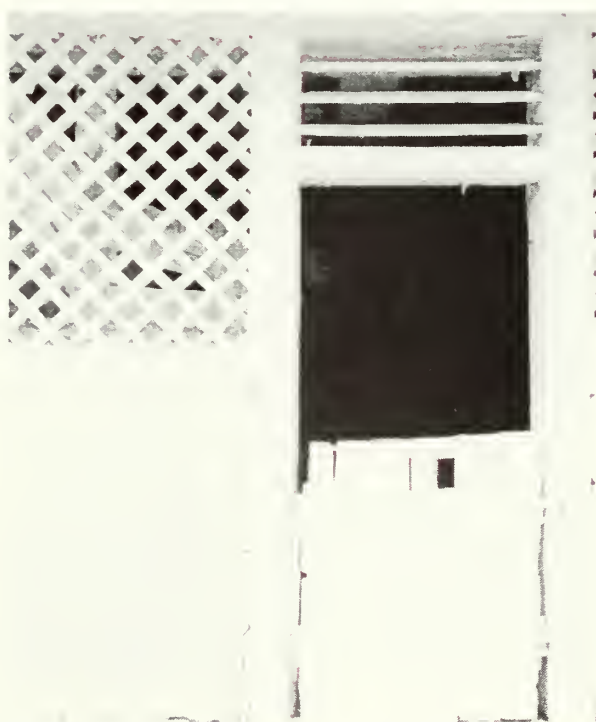
The condition of the doors throughout the structure is fair to poor: all are wood; many are missing altogether, have portions of the door missing, are racked, are out of plumb, or have been substantially rebuilt. Repairs have been made on the large doors at the wagon ramp entrance (the large door on the northeast side was rebuilt)(Figs.181-185), and portions of the winnowing doors that hover over the barnyard on the southeast elevation are not original (Fig.186). The six split doors and the double-swinging doors that lead from the ground level to the barnyard are in a state of disrepair (Figs.187-190). Some original hardware exists, which may be reused (Fig. 191). All doors are framed in wood and most frames are in fair condition, with several areas of insect damage where historic material will have to be replaced (Fig.192). Locks do not exist on any doors (with the exception of a pad lock on the west granary), so there is no way to secure the building (Fig. 193).

Figure 188: Top half of split door missing (southeast elevation).

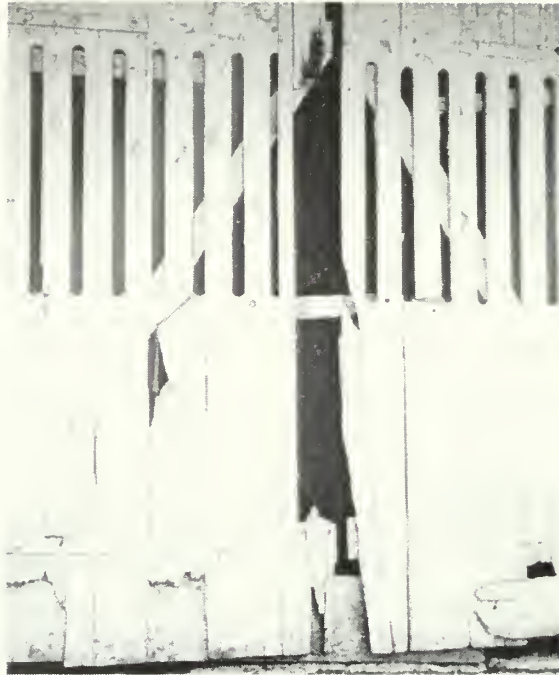
Figure 189: Deteriorated double doors at the southeast elevation.

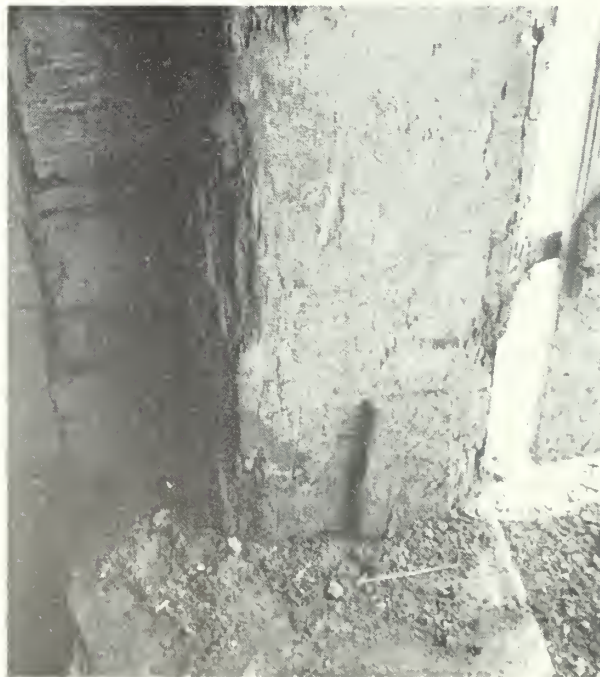
Figure 190: Wood frame of the double doors (southeast elevation). Note insect damage and splintering.
